PRELIMINARY ASSESSMENT REPORT

**CARD BLANC/CARTER
HOUSTON, TEXAS**

EPA CERCLA I.D. NO.: TXD988061446

15 July 1993

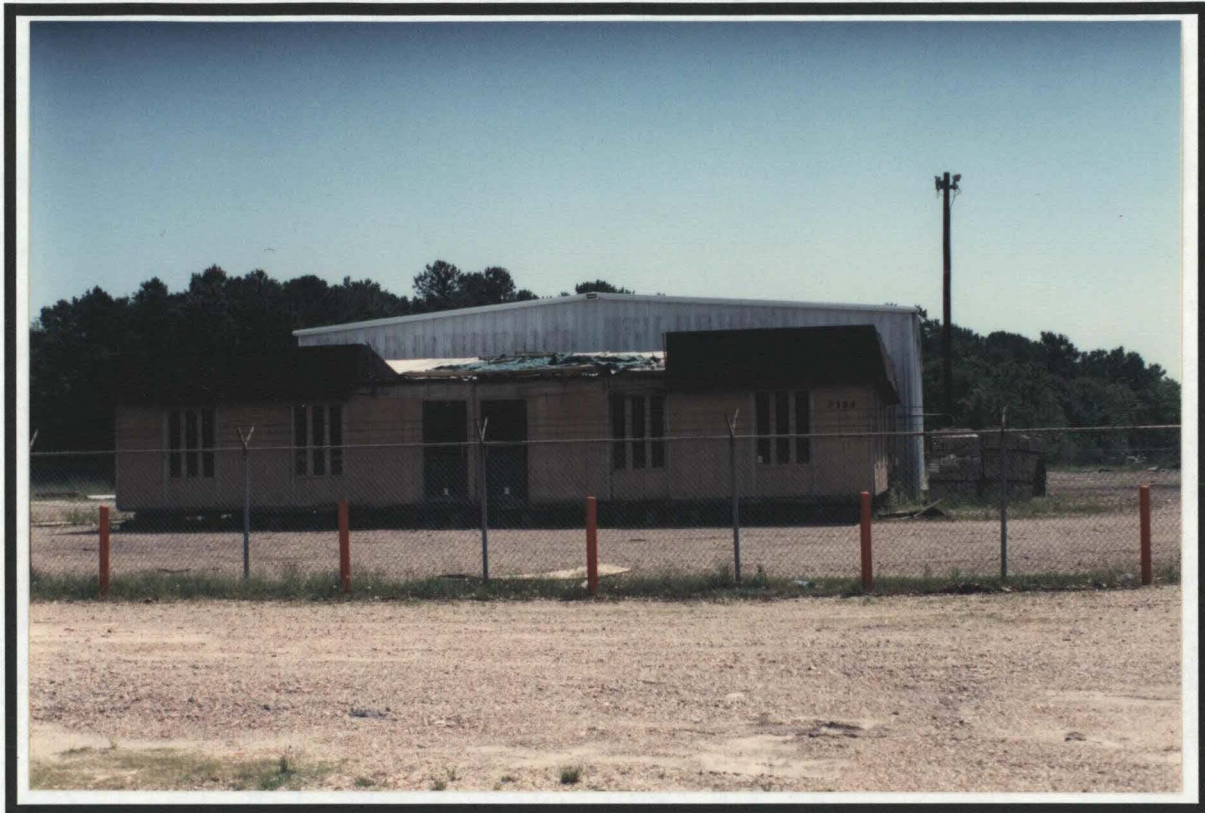
Site Name: CARD BLANC/CARTER
 Site Location: 11532 and 11548 East Hardy Road, Houston, TX
 Cerclis I.D. No.: TXD988061446
 Weston Work Order No.: 04603-022-034-2400
 Photographer: Jeff S. Wormser *JSW*
 Witness: Robert J. Ullmer *JSW for RJU*
 Date of Photograph: 20 May 1993
 Description: The direction of the photograph is east. The photograph shows the west side of Building #1.

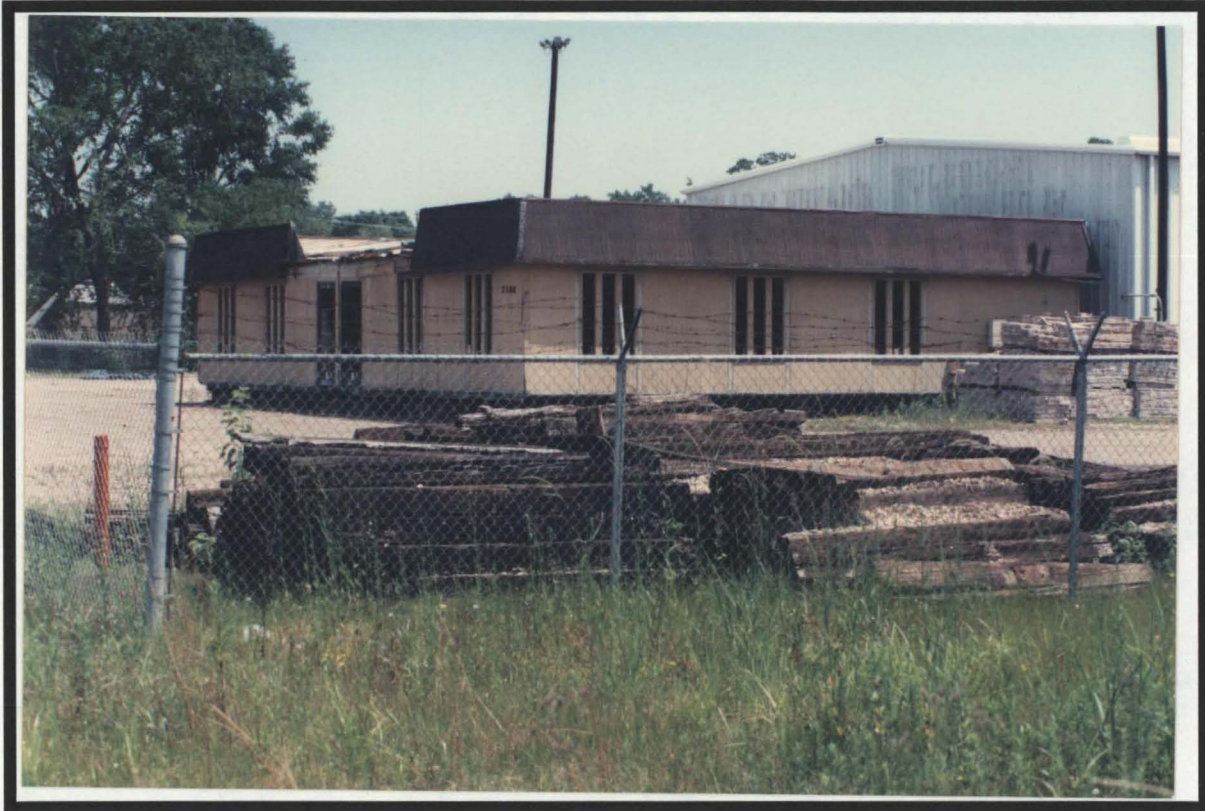
Site Name: CARD BLANC/CARTER
 Site Location: 11532 and 11548 East Hardy Road, Houston, TX
 Cerclis I.D. No.: TXD988061446
 Weston Work Order No.: 04603-022-034-2400
 Photographer: Jeff S. Wormser *JSW*
 Witness: Robert J. Ullmer *JSW for RSU*
 Date of Photograph: 20 May 1993
 Description: The direction of the photograph is northeast. The photograph shows a pile of treated timbers in the foreground. Building #1 is shown in the background.

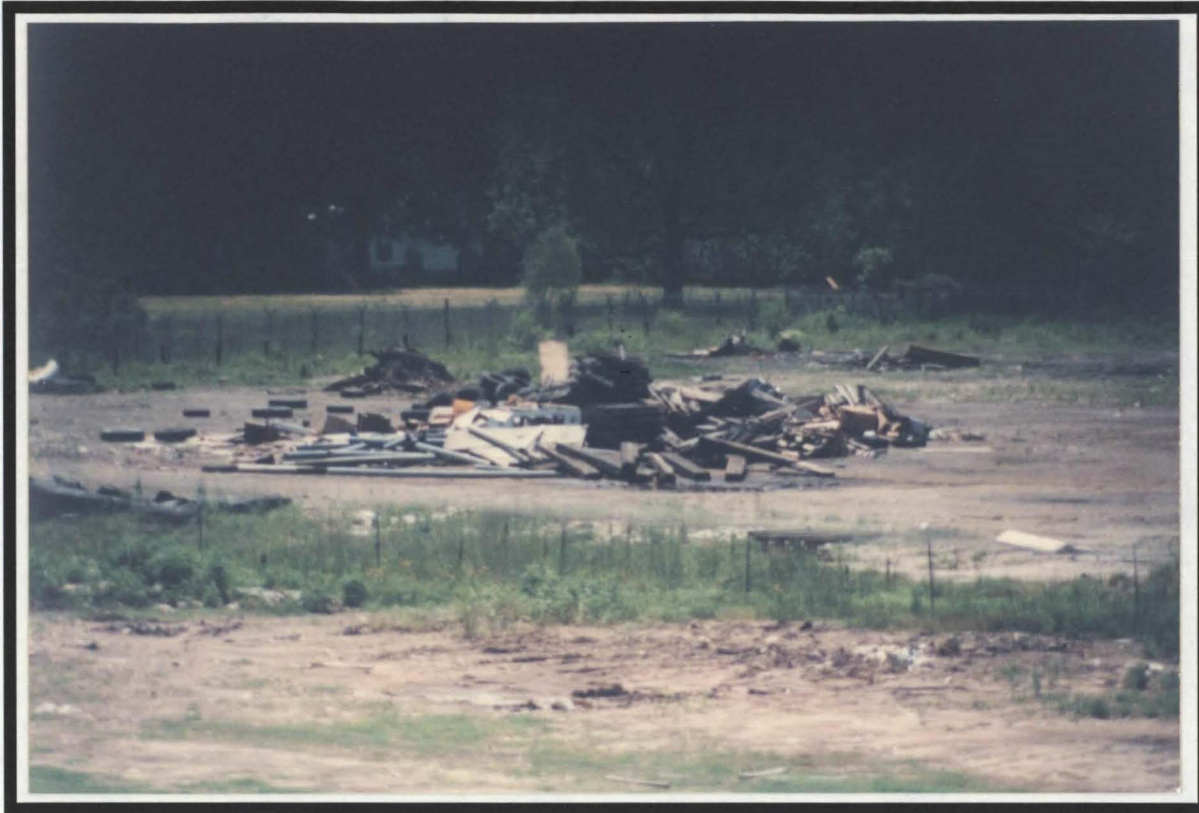
Site Name: CARD BLANC/CARTER
 Site Location: 11532 and 11548 East Hardy Road, Houston, TX
 Cerclis I.D. No.: TXD988061446
 Weston Work Order No.: 04603-022-034-2400
 Photographer: Jeff S. Wormser *QSW*
 Witness: Robert J. Ullmer *QSW for RJU*
 Date of Photograph: 20 May 1993
 Description: The direction of the photograph is southeast. The photograph shows a scrap pile located in the eastern portion of the Card Blanc property.

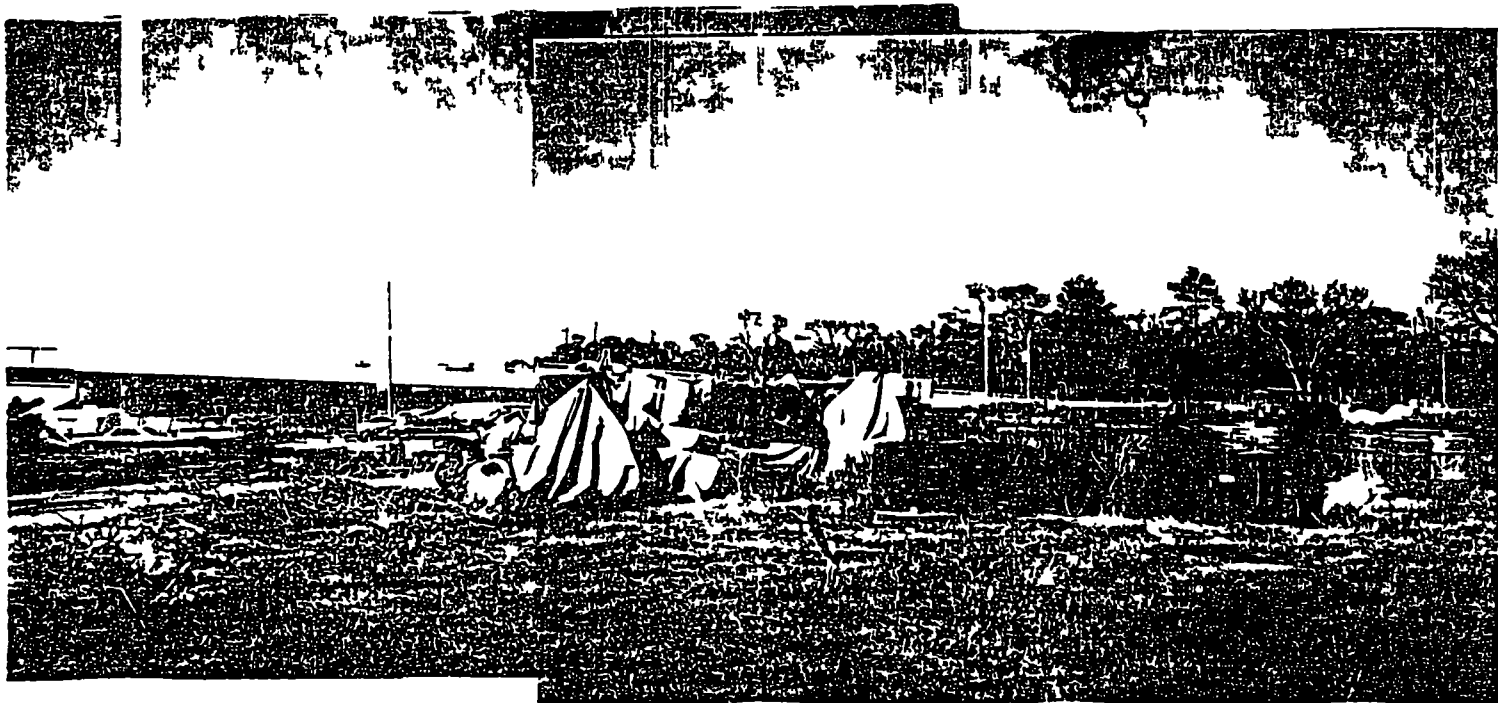
Photograph No 2 A panoramic view of the abandoned drums
looking in a northerly direction

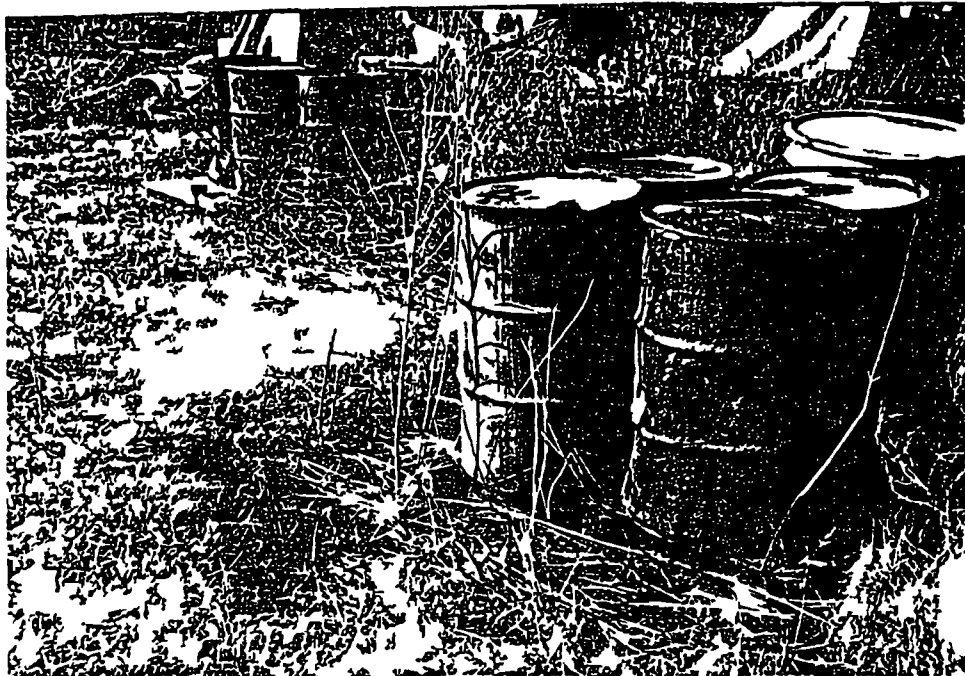
Photograph No 5

A photograph of several leaking metal drums. Note that some of the waste has saturated the soil in the foreground of the photograph. The photograph was taken looking in a northwesterly direction.

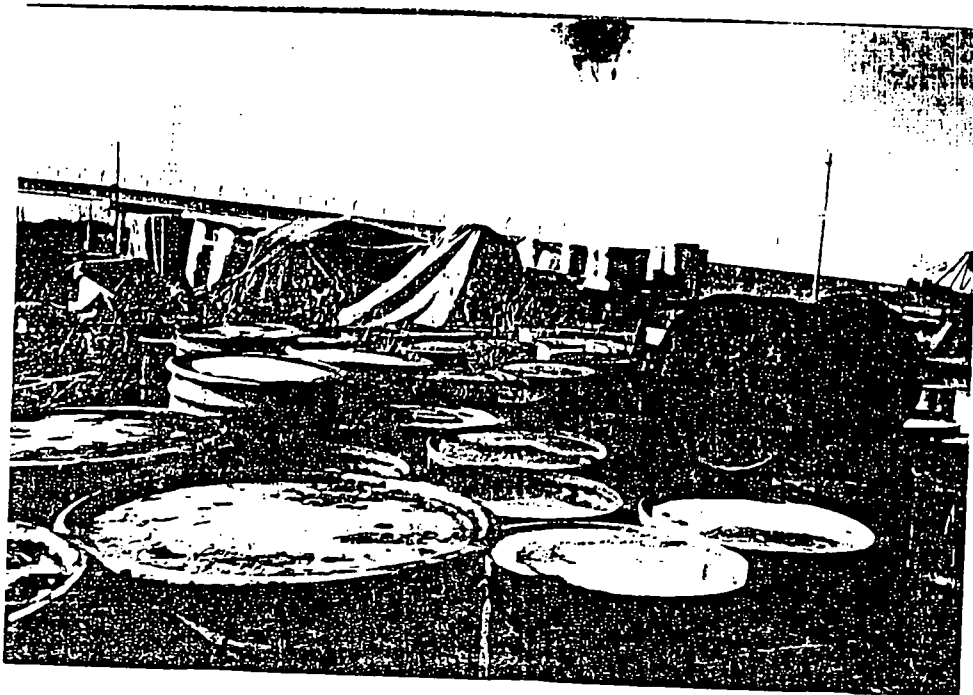
Photograph No. 6: A photograph of several leaking metal drums. Note the rust holes in the drum lids. The photograph was taken looking in a northwesterly direction.

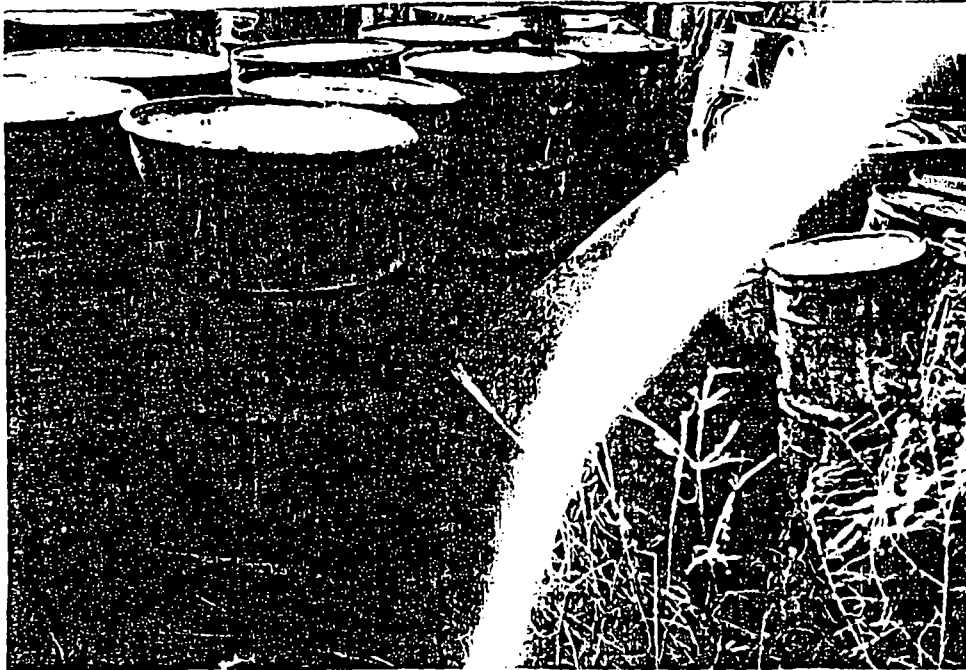
Photograph No. 7: A photograph of several leaking metal drums. Note the discolored soil near the pallet. The photograph was taken looking in a northwesterly direction.

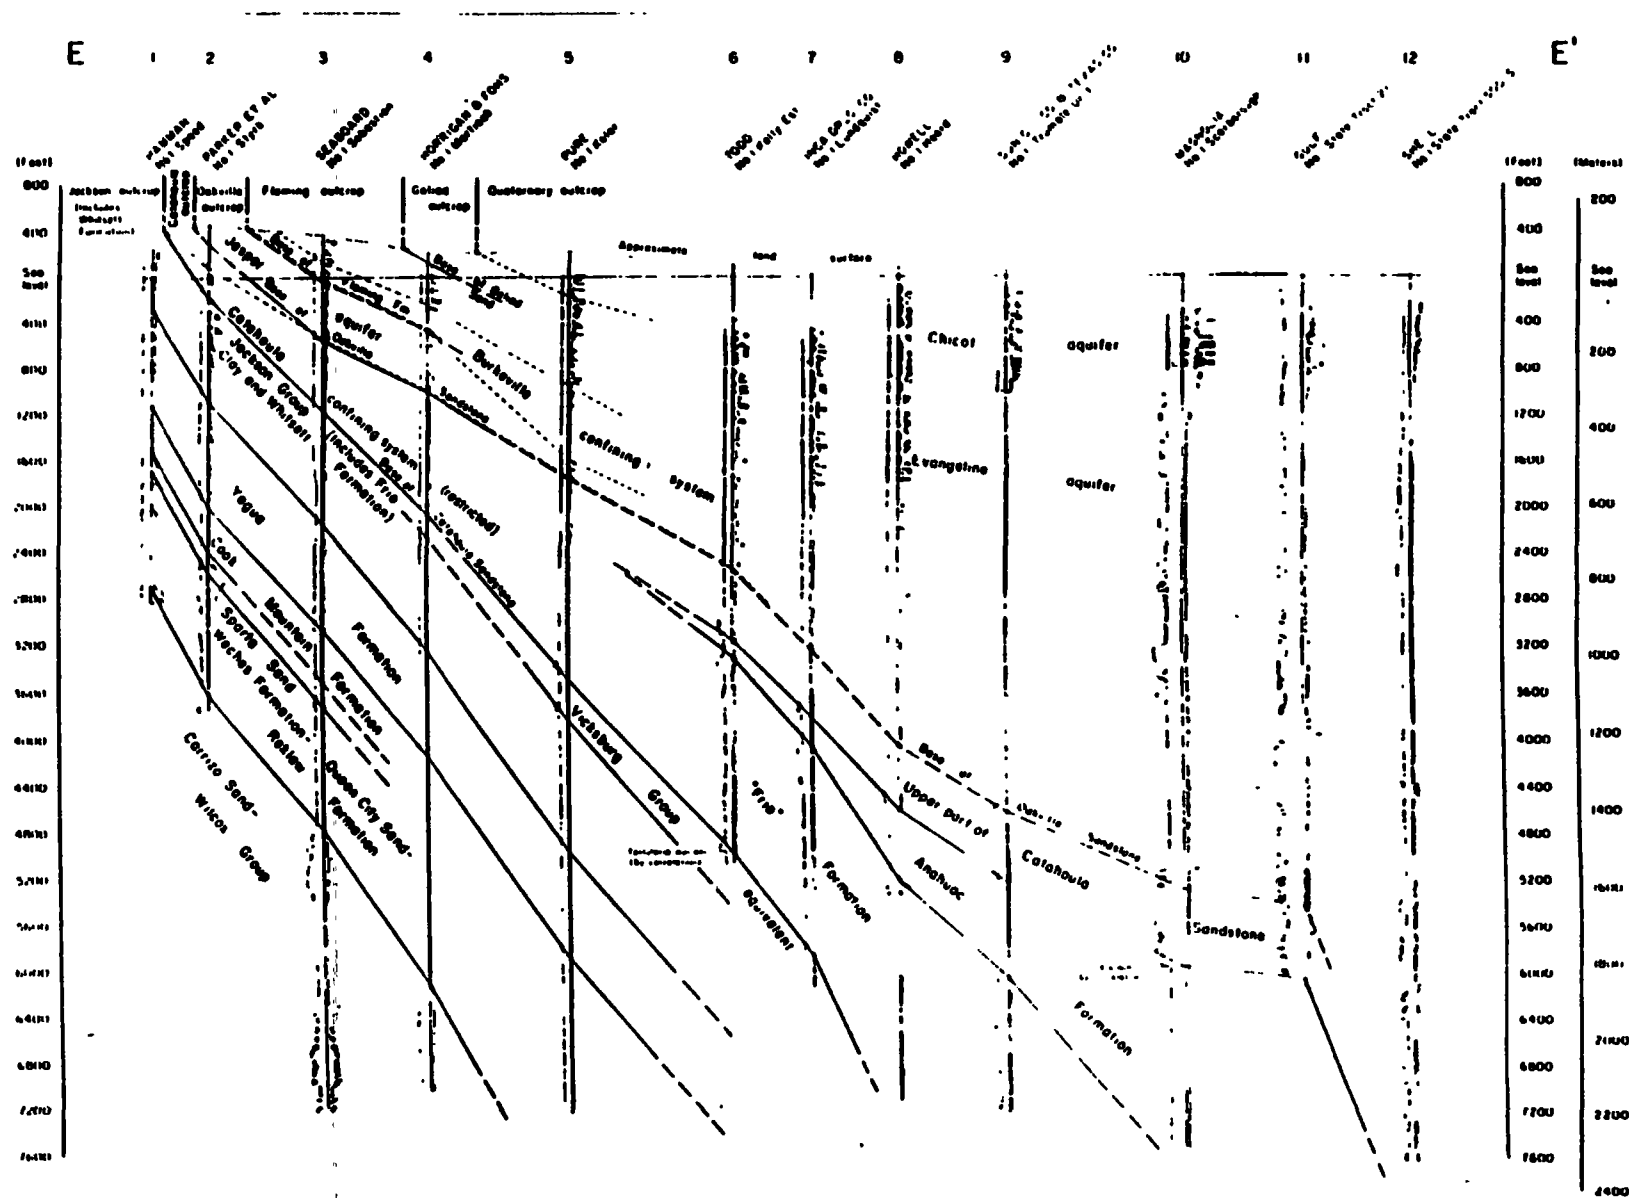
Figure 6
Stratigraphic and Hydrogeologic Section E-E'

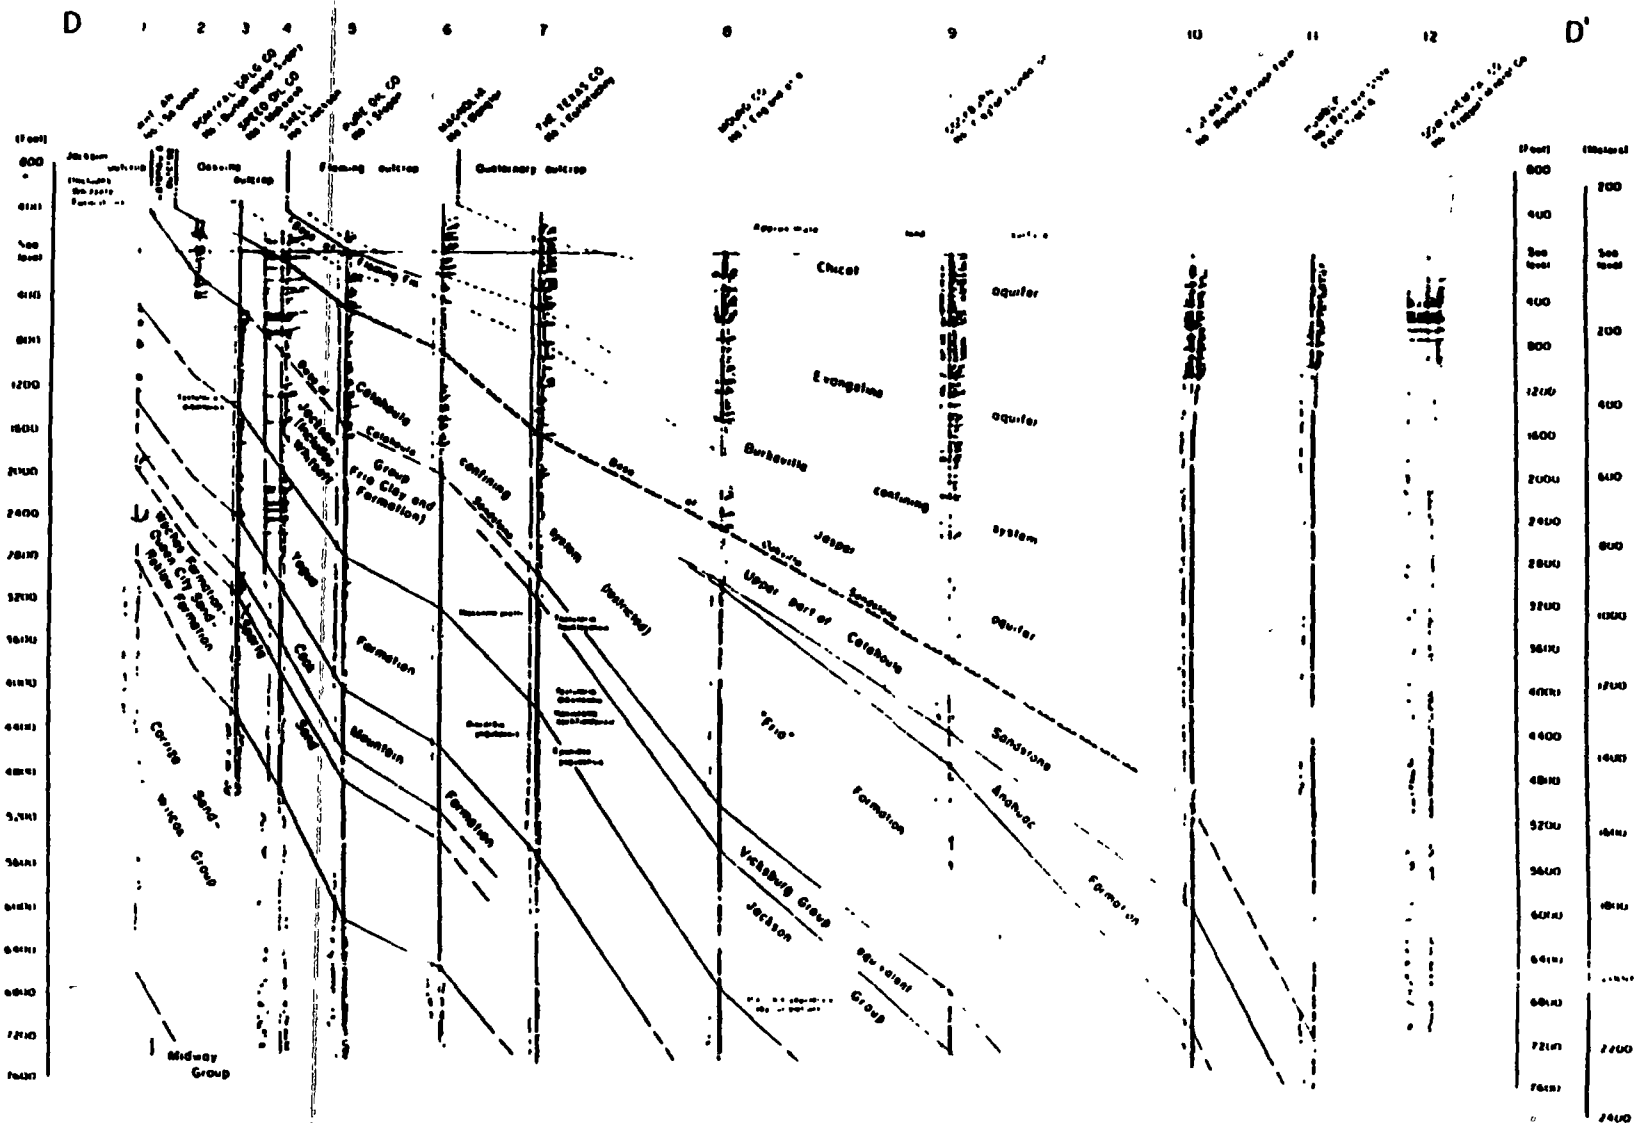
Figure 5
Stratigraphic and Hydrogeologic Section D-D'

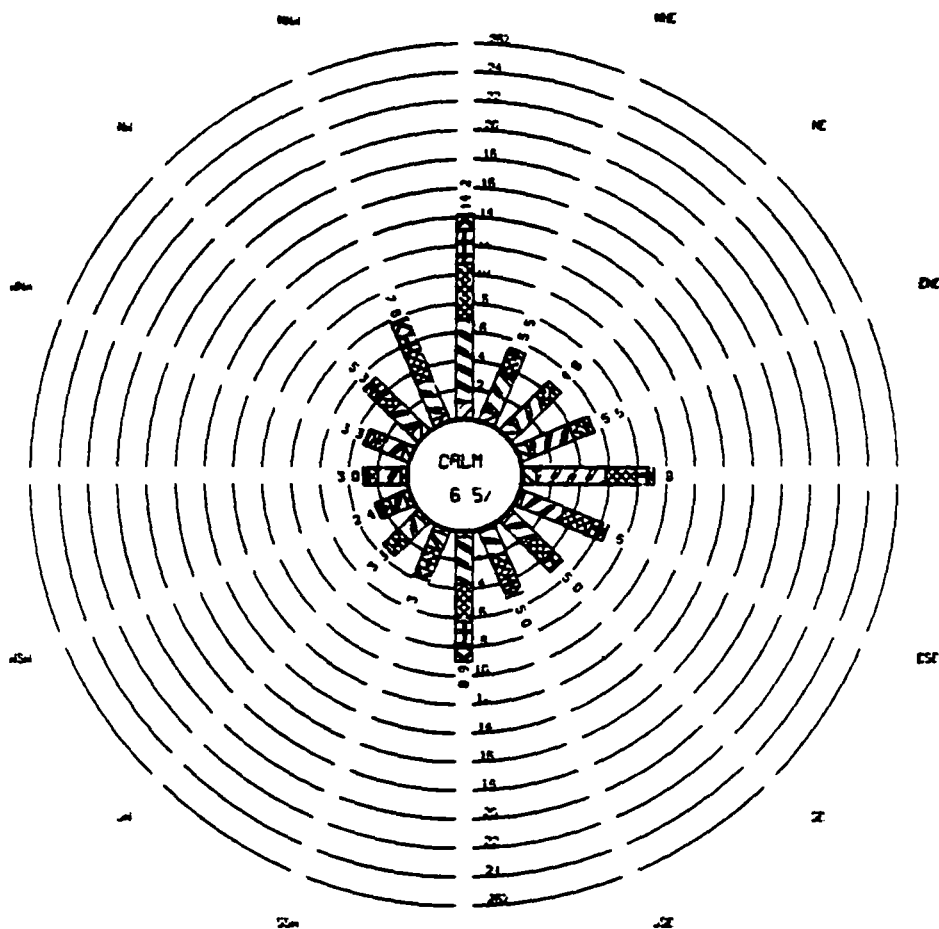
HOUSTON INTERCONTINENTAL AP
STATION #12960

PERIOD OF REPORT
 YEAR(S) ANALYZED 1971 -- 1990
 MONTHS DEC -- FEB
 HOURS OF DAY 0000 - 2300

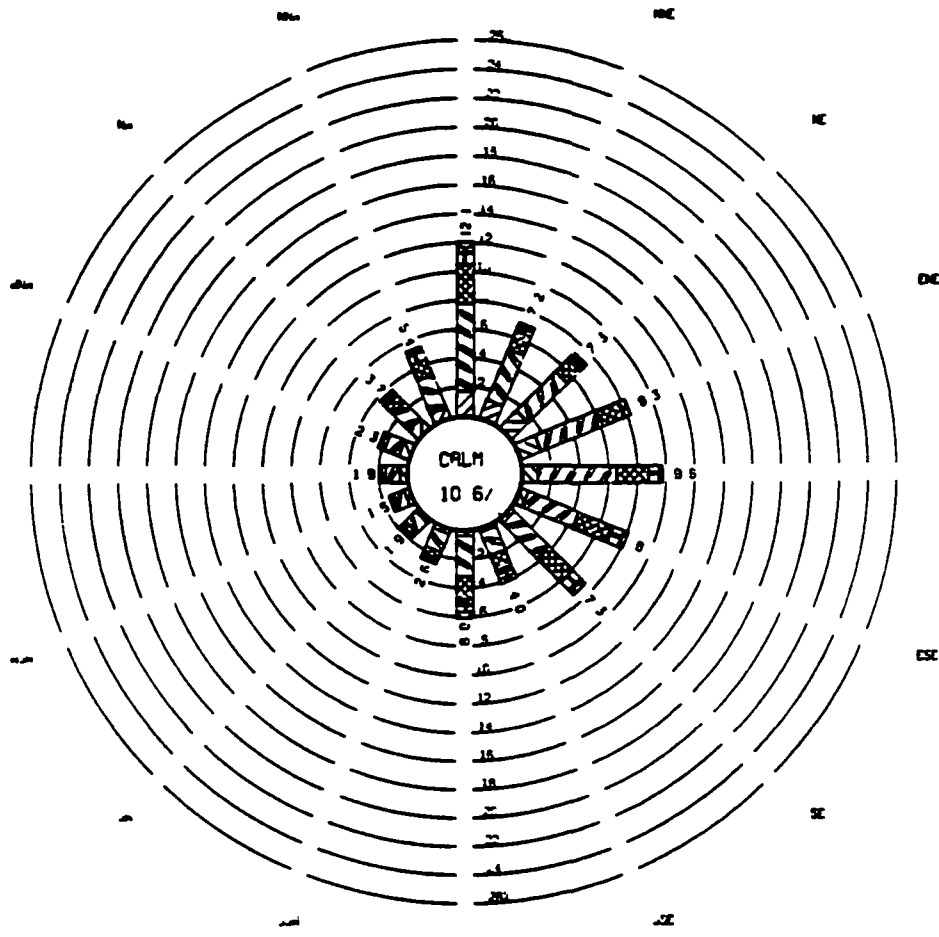
HOUSTON INTERCONTIN. --- STATION #12960

PERIOD OF REPORT
YEAR(S) ANALYZED 1971 -- 1980
MONTHS SEPT -- NOV
HOURS OF DAY 0000 -- 2300
